Balconies Before and After Moving the Meetinghouse in 1836

Anne Krantz, Historian

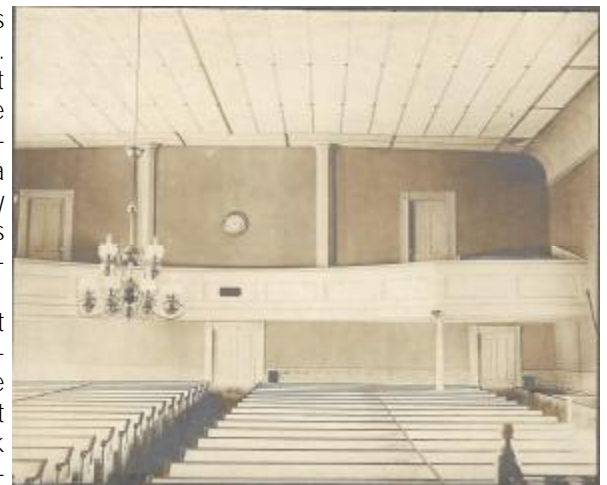
Balcony with Wall

When the meetinghouse was moved and pivoted so the previous west gable or steeple end faced south (the street), the steeple end was redesigned with a flat front. The corners were extended to line up with the front of the tower which added more space inside. The straight, flat front with the gable superimposed on the tower gave the building the Greek Revival look. The added space provided the entry space for the two additional front doors and the hallway at the top of the stairs on the sanctuary level. The staircases leading to the balcony are in each corner. These steep and narrow stairways are unchanged since 1836, according to Charlie Vars who rebuilt the balcony in 1997. He explained that in 1997, the center of the balcony remained as it was left in 1836: an empty, unfinished space. At some point a wall was installed across the balcony lined up with the two tower posts cutting off all but two rows of balcony pews, as shown in the photo to the right.

But by the time Charlie joined in 1975 this partition had been removed, exposing the unfinished center balcony area; a primitive and unsafe situation. Access was by an aisle from the top of each stairs, running along the side of the pews with steps going down to the bottom pew. There were only four bench pews remaining, because one row had been removed for the wall. A row was added - the one with the panel end. These pews had doors and the hinge cutouts can still be seen. Doors were a good idea because the aisle ramp had no railing, and the center balcony space was the level of the narthex ceiling below that created a significant drop from the top of the stairs

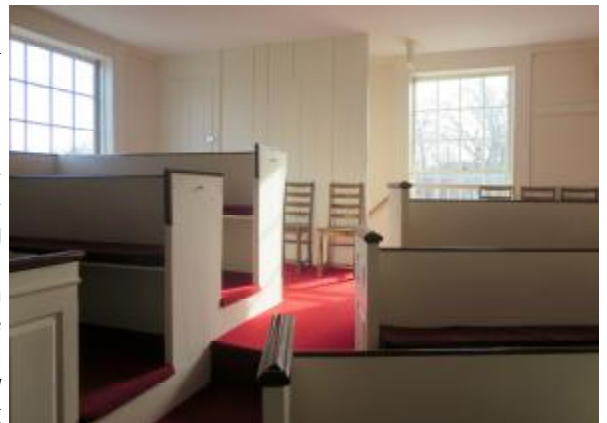
Balcony Today

In 1979 Charlie recruited a team of volunteers to finally build the center balcony seating. This was a major construction project because the floor in the center space was failing and couldn't support any weight. They attached huge wooden beams to the steeple posts and hung the cross beams for a solid floor. The tiered risers for the pews were built on top. The Varses donated the new center pews adding lots more seating. These four rows of new pew benches provide seating for 50 to 60.

The front side of the balcony wall with the lovely paneling is the same as it looked in 1836. The 1774 meetinghouse gallery/balcony at this west tower end would have been inside our present sanctuary, in front of the tower. Now the balcony is pushed back under the tower; the huge pillars toward the front of the balcony hide the original 13" square posts holding up the tower. The other two tower posts are enclosed in the front walls.
